Navajo Abandoned Uranium Mine

Site Screen Report

Plot 8 AUM Site

August 2010

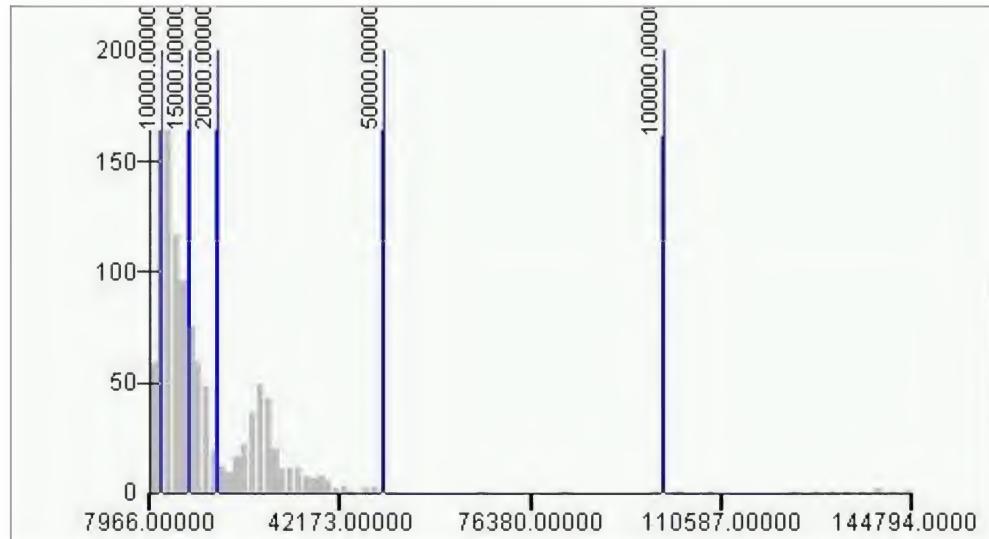
Count:	1128
Minimum:	7966.00000
Maximum:	144794.00000
Sum:	20495932.00000
Mean:	18170.15248
Median:	13761.50000
Standard Deviation:	14198.05719

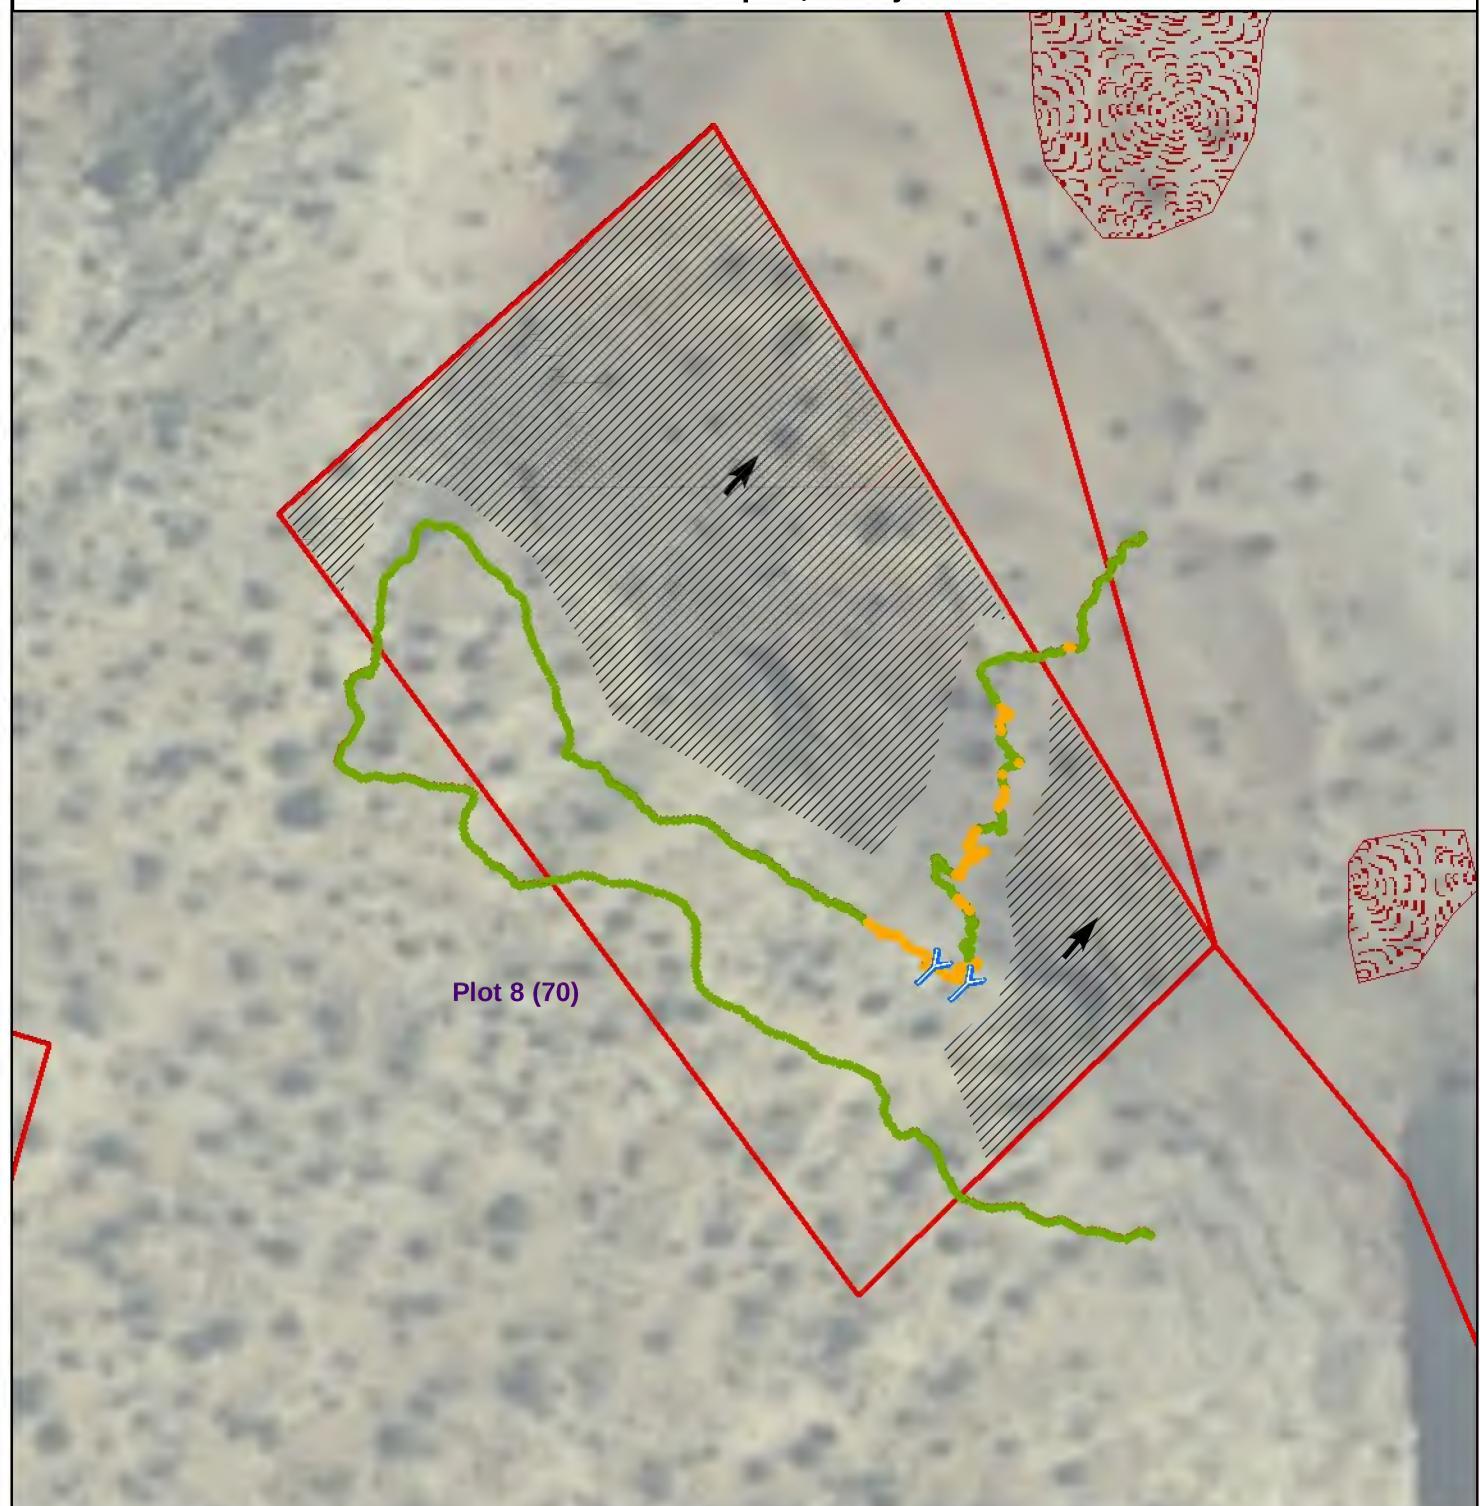
Figure 1 - Gamma Radiation Measurements, Above Two Times Background
Plot 8 (70)
Teeec Nos Pos Chapter, Navajo Nation

A total of 1,128 gamma radiation measurements were collected from the mine site, ranging from 7,966 cpm to 144,794 cpm. Measurements collected in the scattered waste rock in the drainage below the adits were found at levels up to approximately 140,000 cpm, and near the adit at levels up to approximately 40,000 cpm. The measurements are represented in Figures 1 and 2.
